# MEASURING DYNAMIC IMPACT ON AGED TIMBER BRIDGES; SOME EXPERIMENTAL OPTIONS

John Moore<sup>1,\*</sup>, Saeed Mahini<sup>1</sup>

<sup>1</sup>Department of Civil Engineering, University of New England, Armidale, NSW

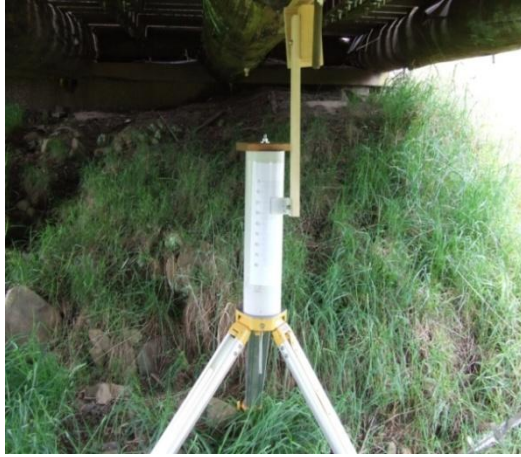
Figure 3: Graduated scale, staff and vernier

Deflections caused by traversing vehicles of known mass over a test bridge (Munsies Bridge, Gostwyck NSW) were recorded using a high speed high quality camera (Casio EX-FH25)(Moore, 2013). The camera was capable of recording at 120 frames per second (fps), 240 fps and 480 fps, with an upper speed of 1000 fps; 120 fps were used in this test. The camera and software were calibrated by comparing the recorded images with the moving sweep-hand of a standard clock. The software used to interpret the images was AVS Video Editor 5.2 sourced from Online Media Technologies Ltd, UK. The recordings from the video camera were used to identify the instantaneous mid-span deflections from a test vehicle moving across the bridge as measured with a graduated scale and vernier (refer Figures 3 and 4) .

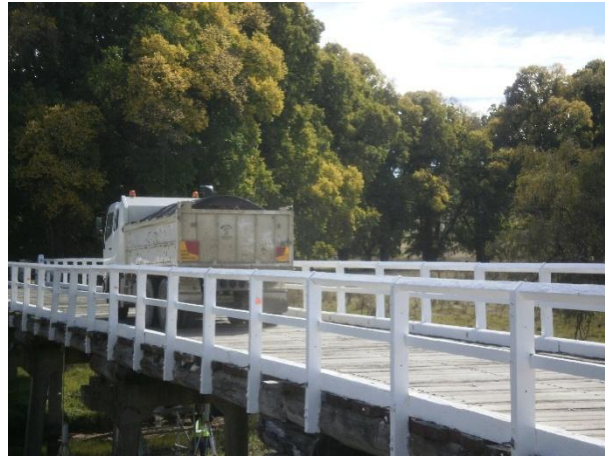
Figure 7: Test vehicle on bridge

To validate that the deflection data was a reasonable reflection of the applied load, a continuous record was made of the test vehicle traversing Span 4. The combined influence line was computed for both axles of the test vehicle (refer Table 2) and is shown in Figure 7 (smooth light grey line) The impact factor (Mufti, 2001: Equation 2.4) as determined in Table 5 and Figure 8 was 0.14.

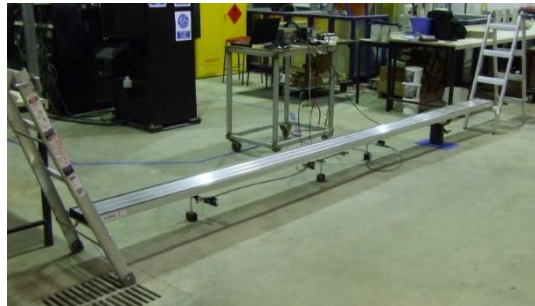
Figure 10: Beam used to test vibration logging system

To validate other in-service measurements a high quality measurement system is required and to test such a system a Tokyo Sokki Kenkyujo TMR 200 Multi-recorder was tested in a laboratory situation. The first requirement is that samples can be recorded at sufficient speed to determine the peak mid-span deflection of a timber bridge girder. If a point load is one half a metre either side of the mid-span then the mid-span deflection will be within 5% of the peak value (Moore, 2009, Appendix C). At a traverse speed of 100 km.h<sup>-1</sup> the time for such a point load to move half a metre is 18 millisecond. A logging system capable of recording at 200 samples per second or higher (5 milliseconds between samples) is thus an appropriate system to use to record dynamic deflection in sufficient detail to accurately identify the peak deflection. The test system that was setup in the laboratory comprised: a simply supported 5 metre aluminium beam (plank); a TMR 200 Multi-recorder together with a TMR-231 Voltage/Thermocouple unit and a computer interface sampling at five millisecond intervals; and a Micro-Epsilon optoNCDT 1402 laser sensor to measure the deflection near mid-span when deflected by an impulse load (refer Figure 10). The beam was loaded by stepping onto it and causing it to vibrate at its natural frequency. The resultant transient was as shown in Figure 11 and a cycle of the transient shown in Figure 12. The measured period was 1.9 Hz with about 100 samples per cycle.
